The Fire Safety Matters newsletter provides industry stakeholders with the Department of Fire and Emergency Services (DFES) Built Environment Branch (BEB) interpretations or concerns of the codes and standards used for the design of building fire safety systems and DFES Operational Procedures.

## Autumn Message

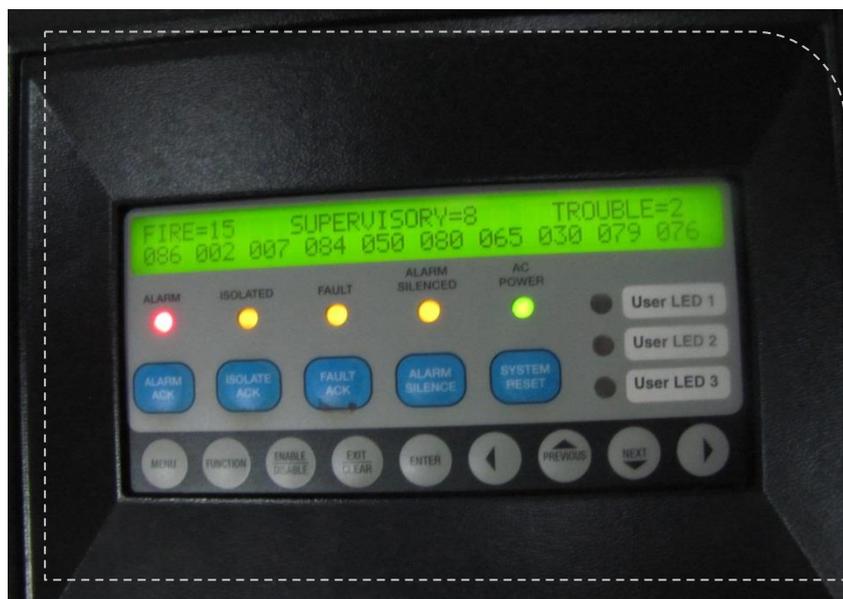
The property Fire Indicator panel.

Following the fire being extinguished, firefighters identified that the Fire Indicator Panel (FIP) was in isolation and that the Building Occupant Warning System did not operate.

that the strata agency displayed a significant lack of understanding of the type of maintenance required and who should be completing it. The booster system had not been maintained and the fire detection system had been put in isolate by one of the building occupants at some time prior to the fire.
